# Manhole Inspection Summary

Manhole # S35YY\_032MH

Insp Date: **12/27/06 9:31 AM**

**Location** Address: **347 33RD ST**

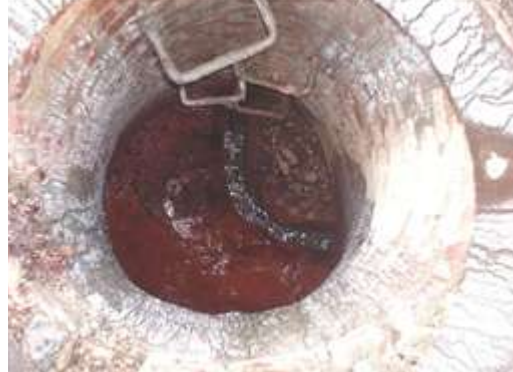
Top View

**Bench** ☒ Exists Material: **Brick** ☐ Parged ☒ **Debris** (not Condition related)

**Steps** Count: **4** Missing: **0** ☒ **Corroded**

Corroded steps. Bench debris.

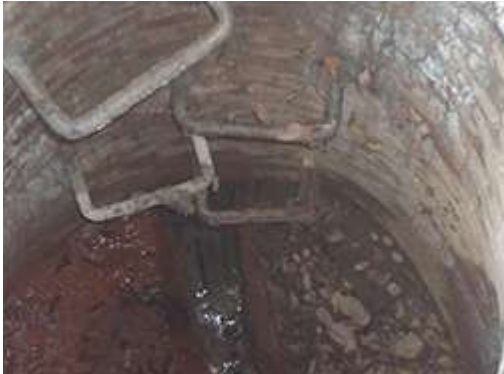
Defect

Infiltration: ☐ None ☐ Joint ☐ Cracks ☐ Mortar ☐ Roots ☒ **Wall**

Barrel infiltration.

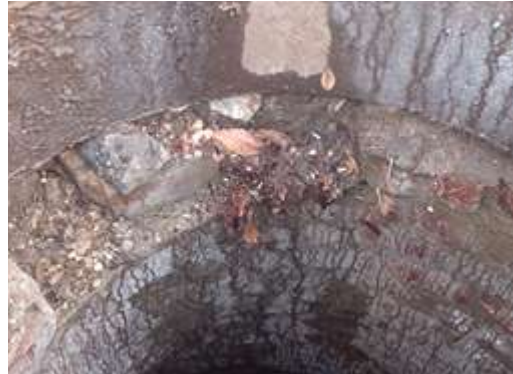
Defect

**Frame** Offset: **6** (in.) Condition: ☐ Sound ☐ Cracked ☒ **Leaks**

Condition: ☐ Sound ☐ Cracked ☐ Root Intrusion ☒ **Loose Brick** ☒ **Deteriorated**

Infiltration: ☐ None ☒ **Joint** ☐ Cracks ☐ Mortar ☐ Roots ☒ **Wall**

Frame leaks. Frame offset. Adjustment deterioration, loose brick and infiltration - other side.

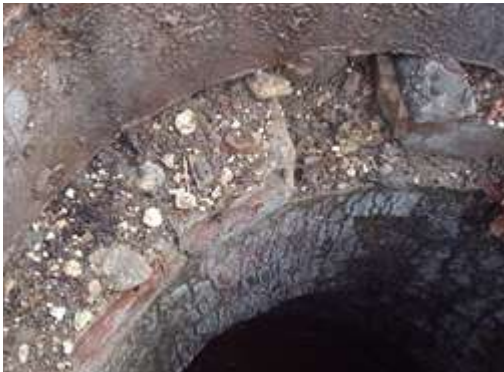
Defect

Frame leaks. Frame offset. Adjustment deterioration, loose brick and infiltration.

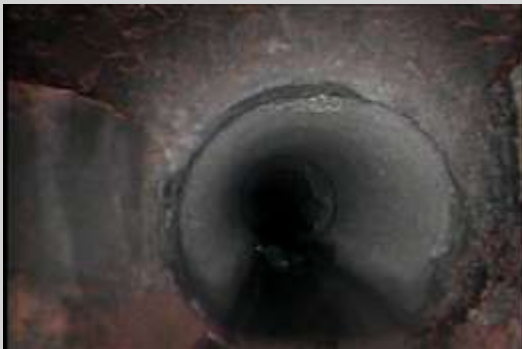
### 8 in. Circular Gravity Sewer Pipe In @ 3 O'Clock

Infiltration: **Evidence** Pipe Seal Cond: **Unknown**
